Aerial Laser Surveying

Data enables Arizona Public Service to locate and eliminate Clearance 2 violations and facilitate long-range planning.

By **Mike Neal**, *Arizona Public Service*

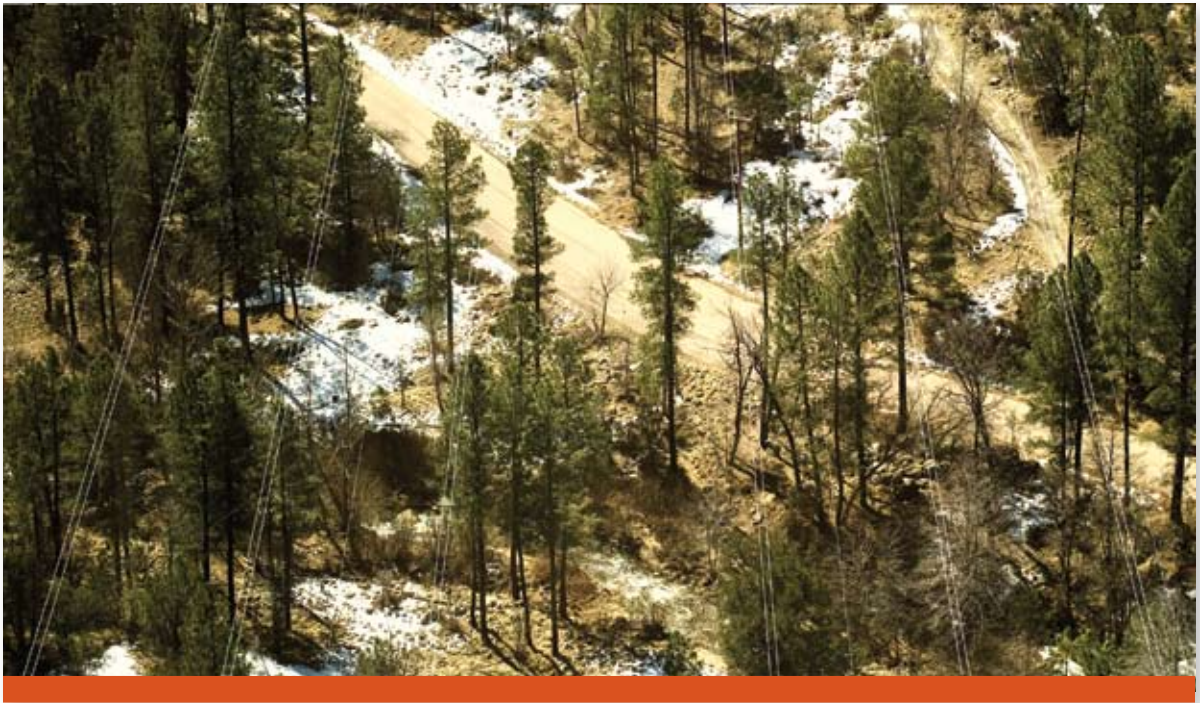
Continuous overlapping high-resolution imagery enables detailed inspections of the right-of-way from the office.

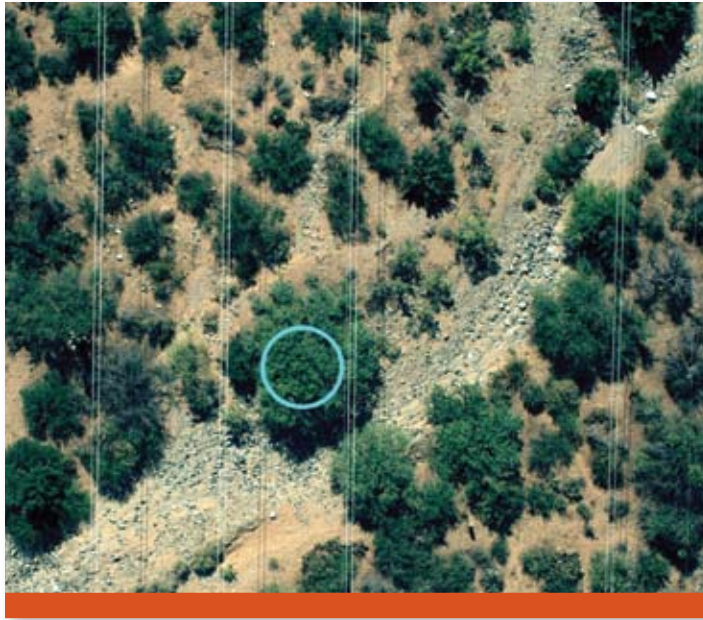
LiDAR surveys enable vegetation managers to immediately identify violations that could otherwise go unnoticed.

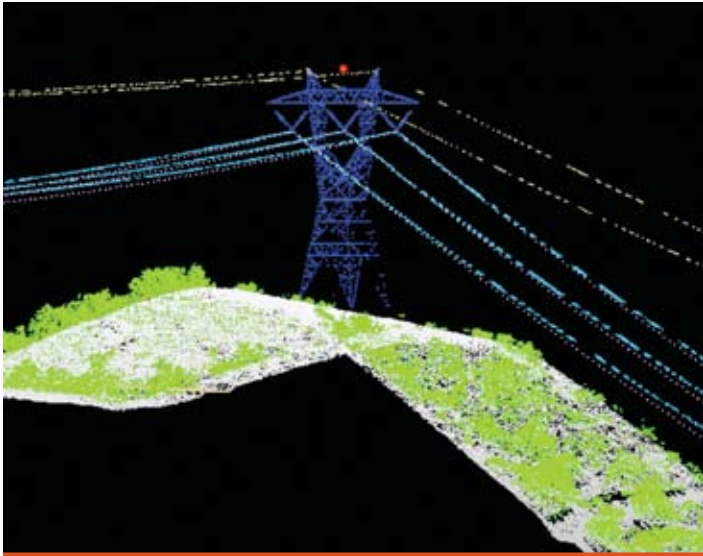
The 3-D LiDAR model is designed for comprehensive vegetation inspection as well as traditional engineering tasks.

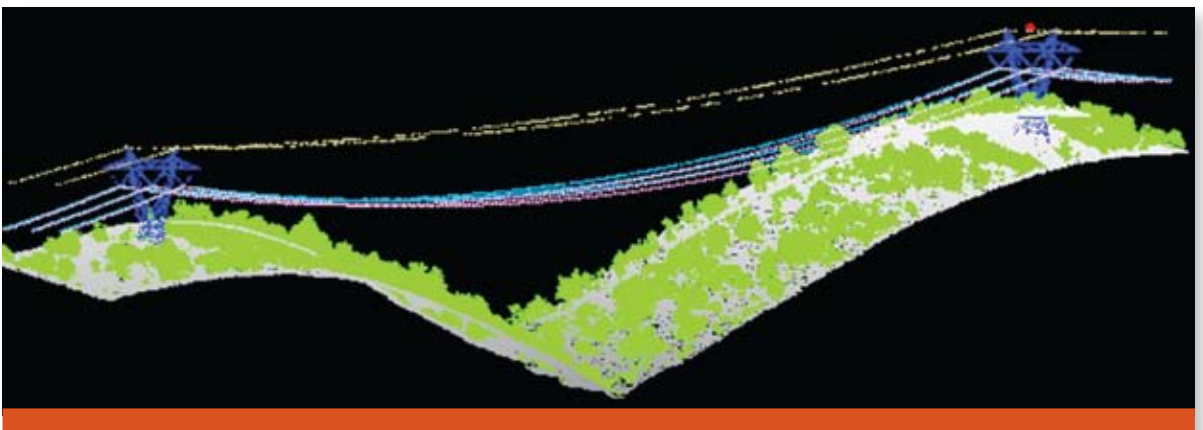
The 3-D LiDAR model allows span-to-span measurable inspection between infrastructure and vegetation. Customized viewers allows easy access to 3D LiDAR and imagery on a span-by-span basis.

The Grid[^]Intel viewer allows easy access to 3-D LiDAR, ortho image and oblique image on a span-by-span basis. It comes with data defined by 3-D layer points, transmission structure, transmission lines, substations center point and boundary, transmission lines out of substation, intersecting lines to transmission lines, Clearance 2 grow-in and fall-in violations at surveyed and at rated temperature, and Clearance 1 violations at surveyed and at rated temperature.
